# GMD SHIPYARD CORP.

Re: GMD Shipyard Administrative Compliance Order CWA-02-2014-3050

GMD Shipyard has continued to work to meet the requirements of the subject compliance order. This letter is an update of activities we are taking to control storm water pollution and other work steps taken to meet the compliance order.

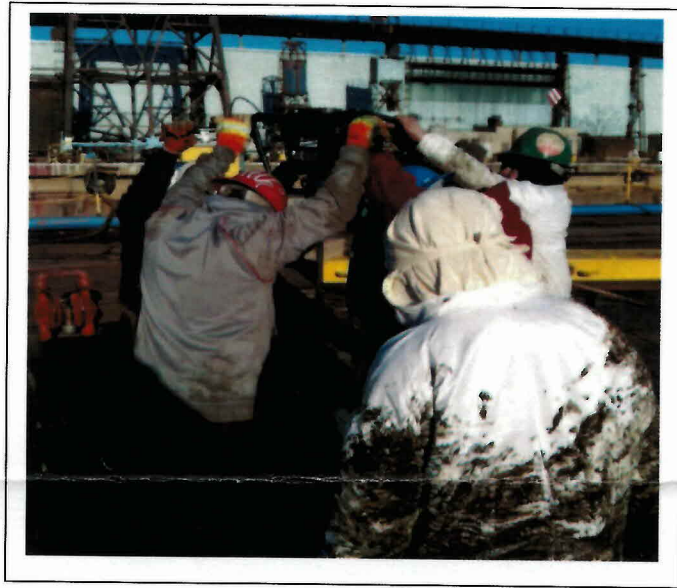
Men using auger machine to cut through drain mud.

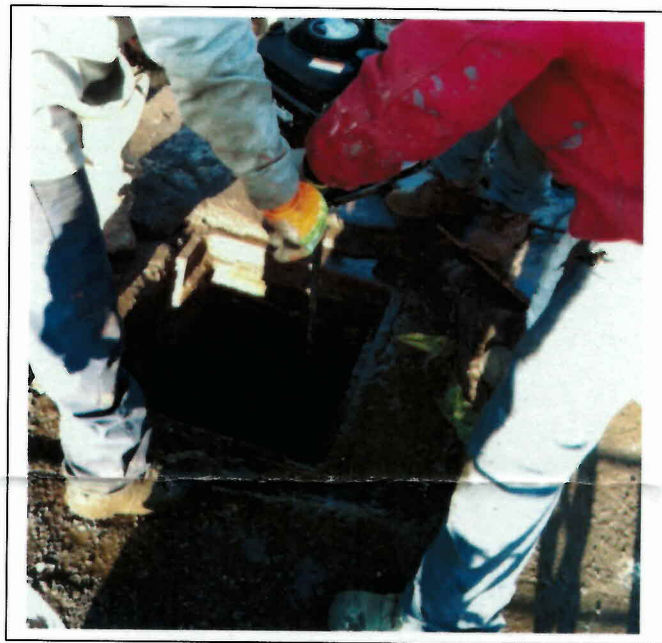
Men handling auger machine after extending the auger down 8 plus feet.

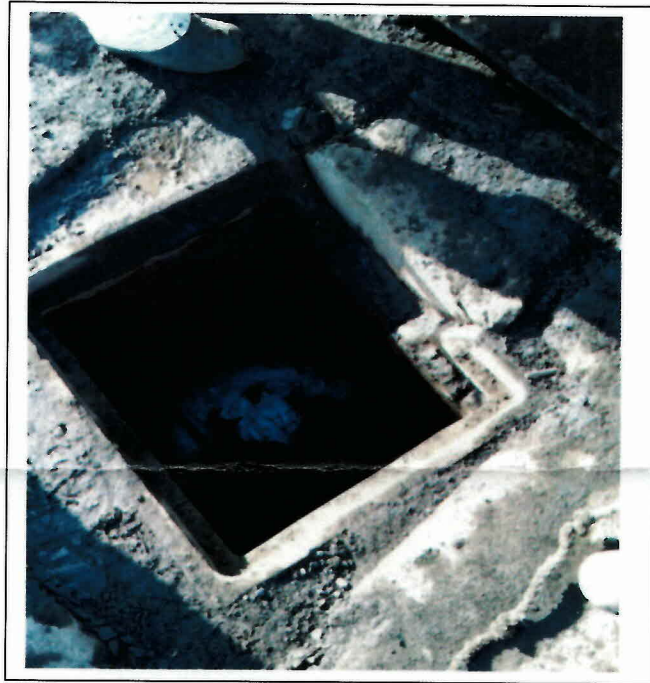
Worker doing final cleaning of drain and inspecting brick drain construction in icy conditions

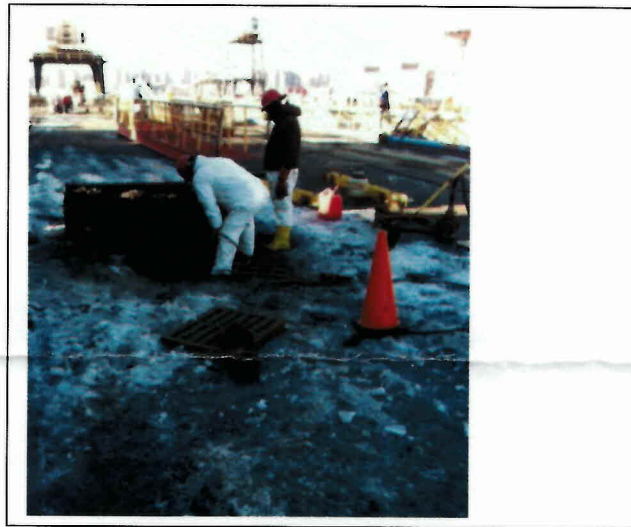
Men working  
Safely, keeping  
Watch over Worker  
inside drain on  
The west side of  
Graving Dock #6

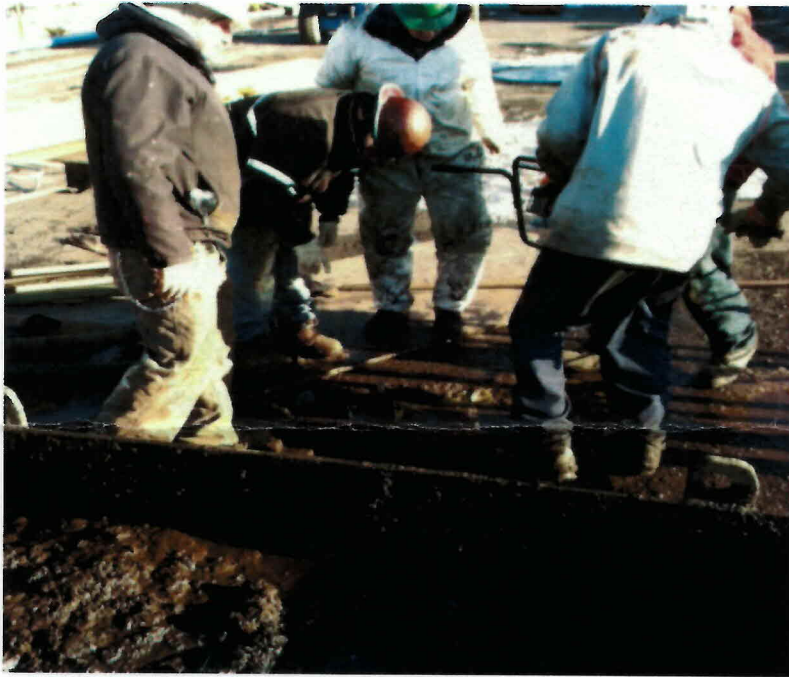
Different Team working/cleaning other drains, this drain is located at the ESE corner and head of Graving Dock #6

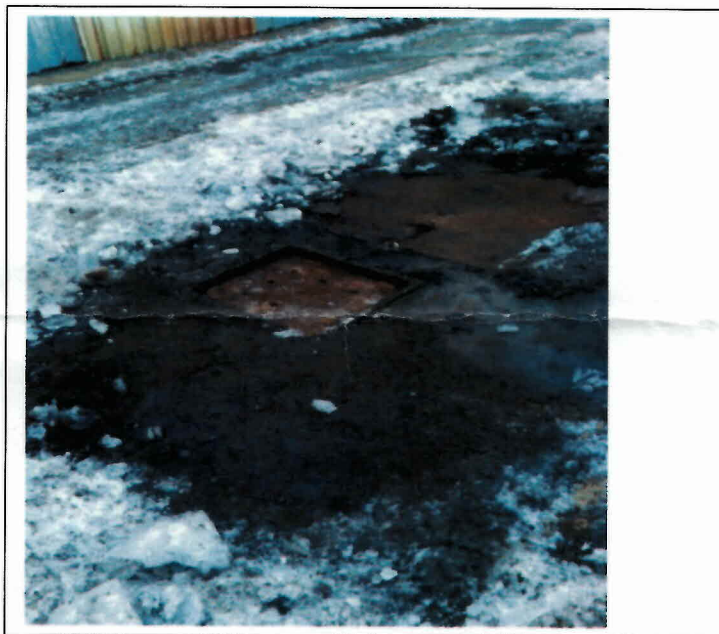
We first chip away the ice and then open and empty the drain. Some drain covers made of cast steel were broke being frozen. Temporary covers of steel sheets are used to replace them until a new drain cover plate can be constructed.

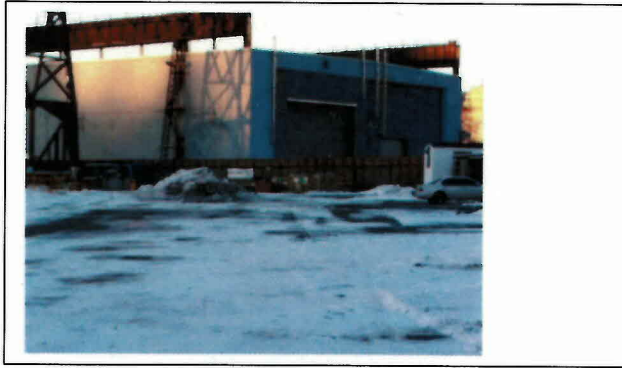
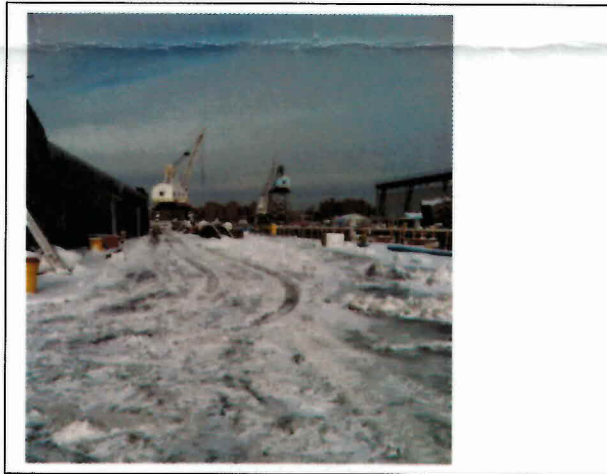
Typical yard cover  
With snow/ice prior  
To melting and  
Working in drains

Yard west side of Graving Dock #6 where all drains have been cleared, now covered with ice and snow.

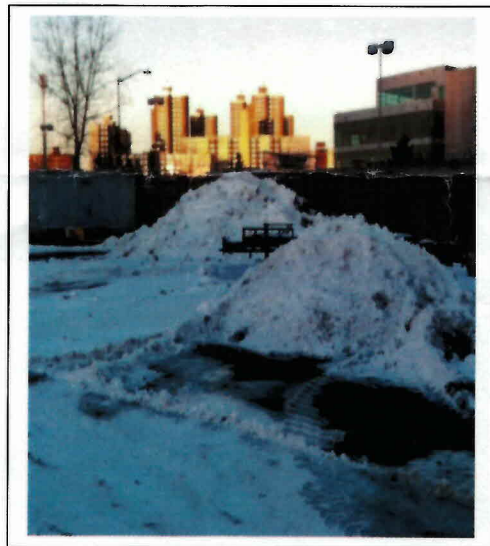
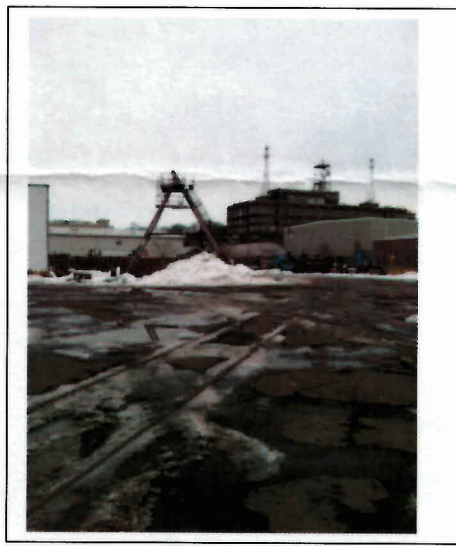
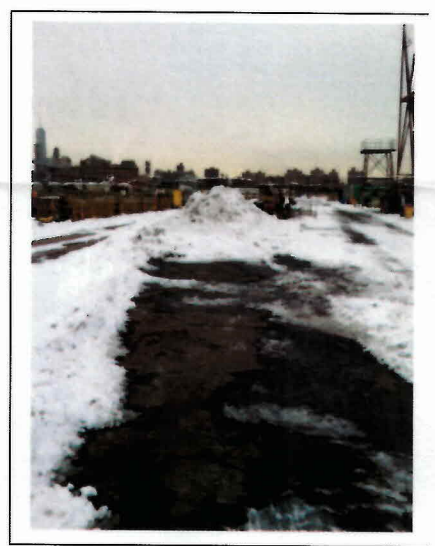
Piles of snow kept on property awaiting melting. Snow is not put into the graving docks or dumped into the surrounding waters.

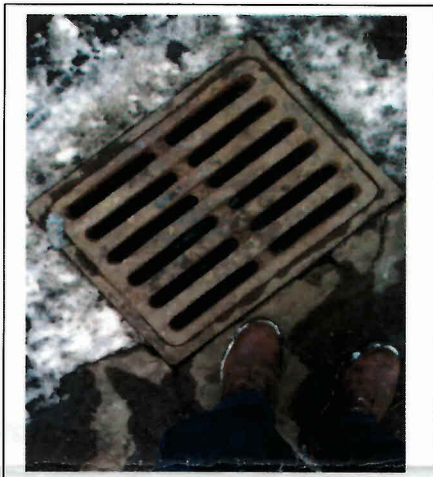
Typical Drain after  
Being emptied with  
Cover put back in  
Position.

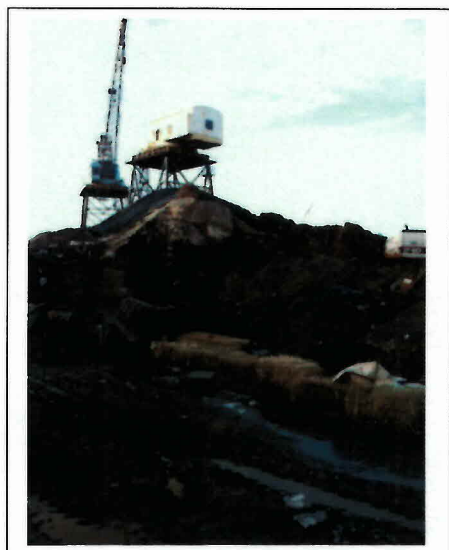
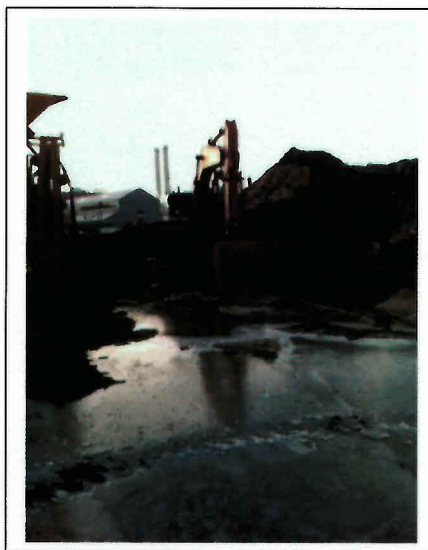
Removal of waste from yard pile:

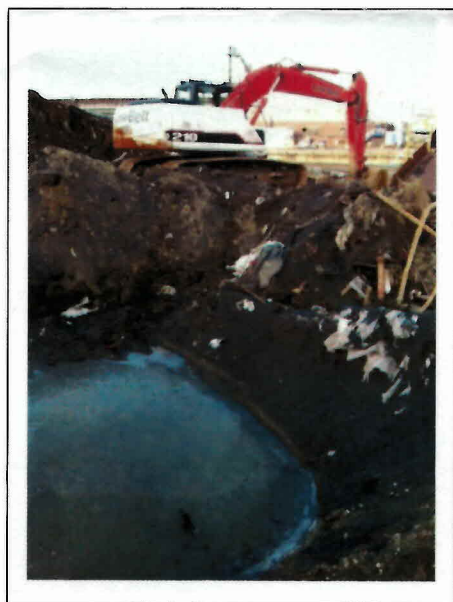
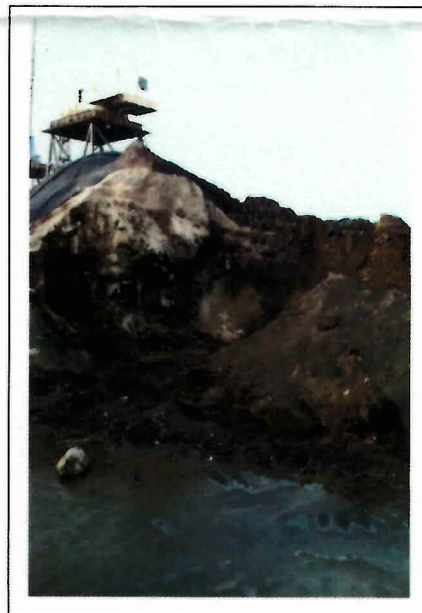
Waste removal continues despite freezing weather. Areas that have been dug out fill with rain and snow water and then freeze.
